Manhole Inspection Summary

Manhole # S09A1_008MH

Insp Date: **5/14/08 9:46 AM**

Location Address: **1260 Benson Av**

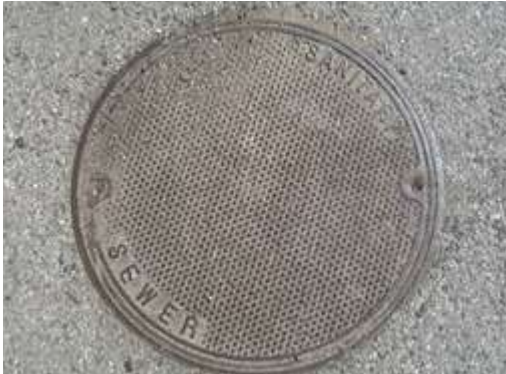
lid pic

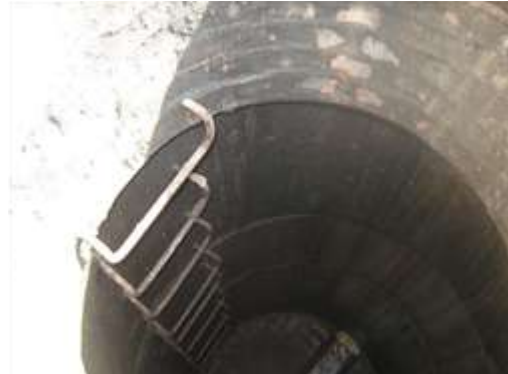
Defect 4

corbel and barrel joint (brick-precaste)
infiltration

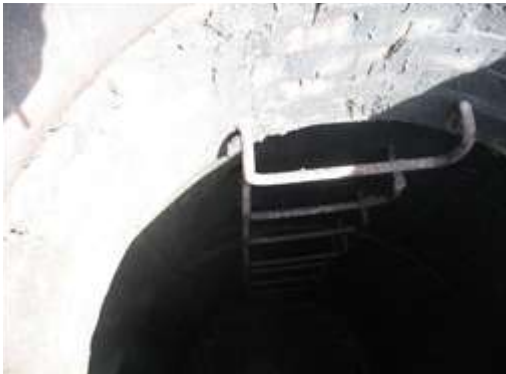
Defect 3

signs of infiltration from frame to lid
connect

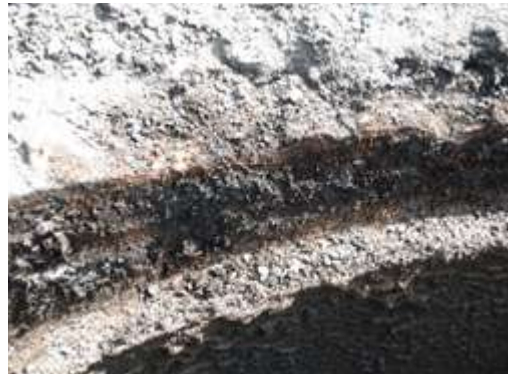
Defect 2

broken frame

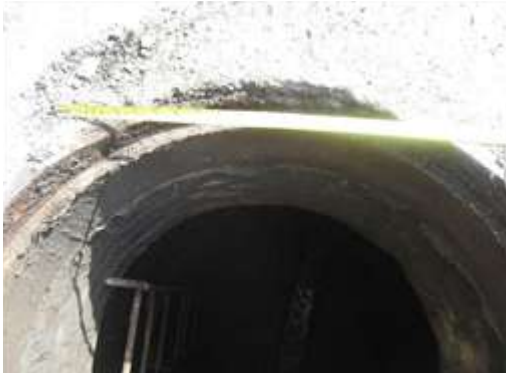
Defect 1

signs of infiltration from frame and chimney

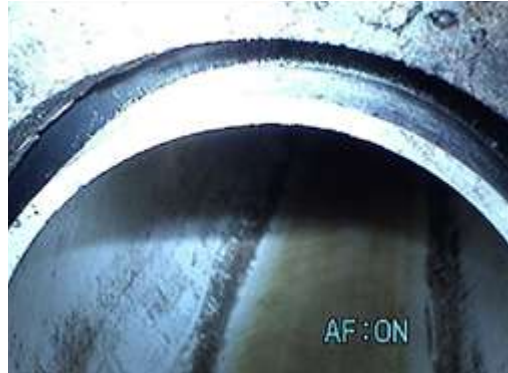
Defect 6

Grouted connection for pipe out would improve flow characteristics

Comments **A concrete mortar mix around the pipe connections in addition to the rubber seals would be a nice touch! - bh**

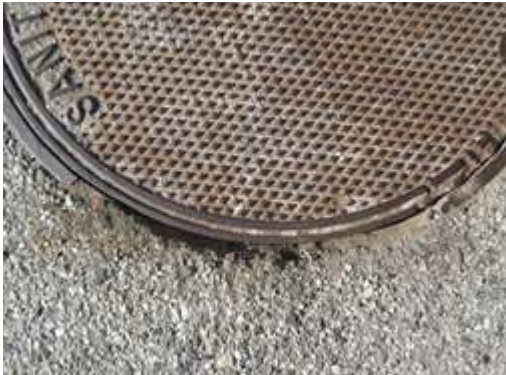
Defect 5

Broken Cover

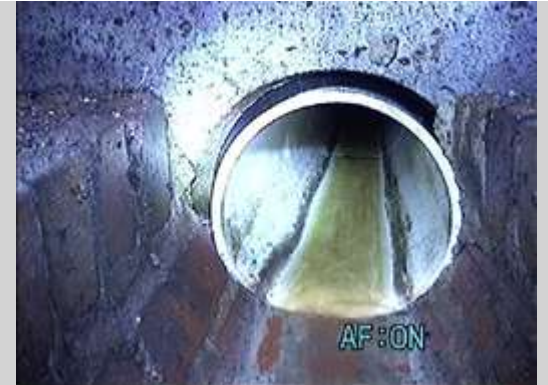
12 O'Clock Outflow

Pipe Height: **8.4** (in.) Rod and Bar (Angled)
Pipe Material: **PVC** ☐ Pipe Lined
Invert Depth: **11.50** (ft.) Flow Characteristics: **Slow**
Deposits: ☒ None ☐ Mud ☐ Sludge ☐ Debris ☐ Grease
Silt Depth: **0** (in.) Deposits Extent:
Infiltration: **None** Pipe Seal Cond: **Sound**

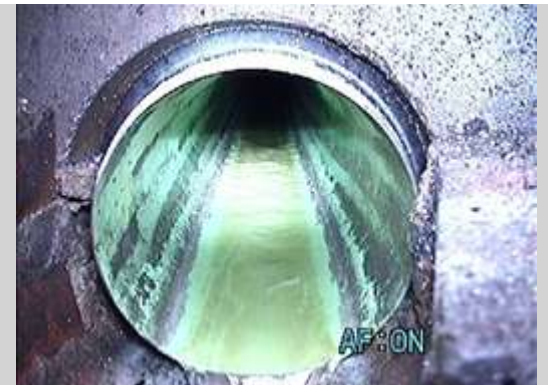
6 O'Clock Inflow

Pipe Height: **8.4** (in.) Rod and Bar (Angled)
Pipe Material: **PVC** ☐ Pipe Lined
Invert Depth: **11.39** (ft.) Flow Characteristics: **Slow**
Deposits: ☒ None ☐ Mud ☐ Sludge ☐ Debris ☐ Grease
Silt Depth: **0** (in.) Deposits Extent:
Infiltration: **None** Pipe Seal Cond: **Sound**
